## VoyagerGX Rev. AA Errata Information

This document describes the errata information for the VoyagerGX (SM501) Rev. AA silicon. All the issues outlined in Errata for the earlier chip revisions have been fixed in Rev. AA silicon.

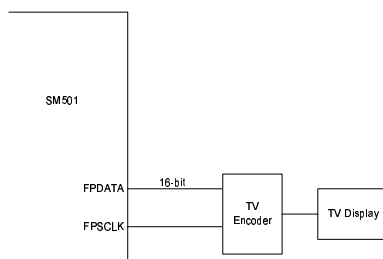
**Description:** When GPIO[63:56] are set to drive TV display, enabling the 8-bit ZV Port will cause TV display blank. However, enabling the 16-bit ZV Port will not cause TV display blank but the ZV capture image is incorrect or broken.

**Root Cause:** The definition of the 8/16-bit ZV Port interfaces between the Capture Control block and the internal MUX are reversed.

When 0x090000[9] is set to 8-bit ZV Port interface, the MUX considers it as 16-bit interface and enables GPIO[63:56] as input mode. Therefore, if GPIO[63:56] are driving TV display, enabling register 0x090000[9] for 8-bit ZV Port interface simultaneously will cause the TV display blank.

**Workaround:** Software Workaround: None. Hardware Workaround: select TV encoder that can be driven by the 16-bit FPDATA as showed in the diagram.

Will be fixed in the future product family.
